Crawford Air/Oil Separator

Metal Fitting Fix

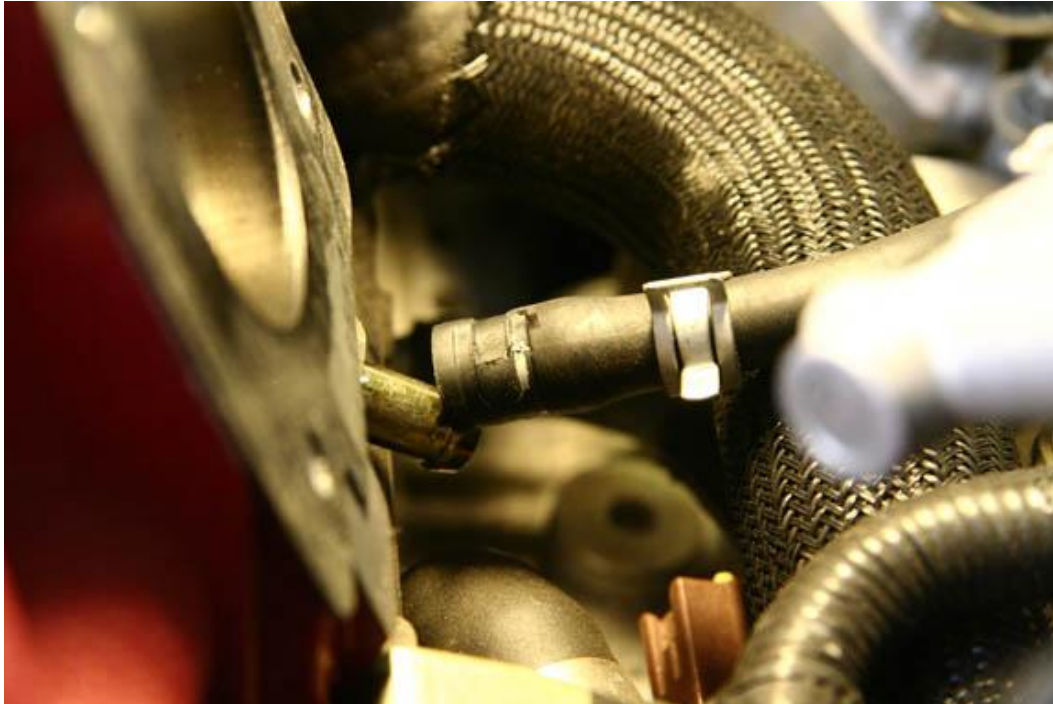
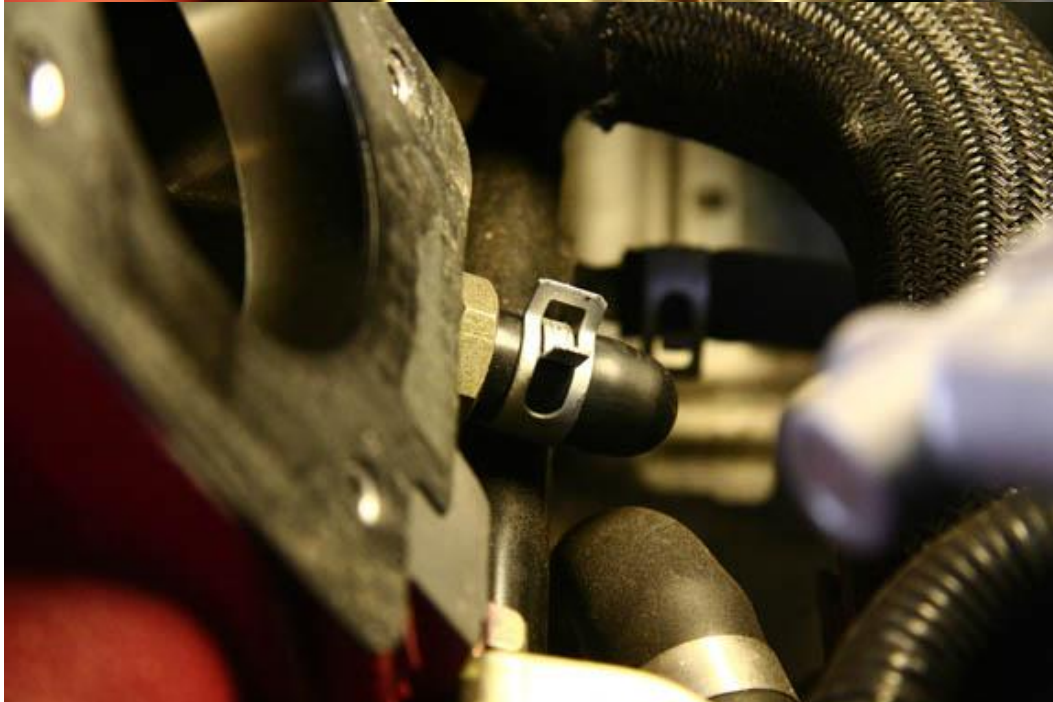
We recently discovered the small rubber cap used to cap off the metal fitting underneath the throttle body is prone to failure. We discovered this on our own STI with 19,000 miles on the clock after hearing a faint whistle while the car was under boost. The ruptured rubber cap basically creates a boost and vacuum leak. Here are a couple photos of the metal fitting on the car:

THE FIX IS EASY. You have three options:

1. Head to your local hardware store, buy a $\frac{1}{4}$ " hollow hex pipe plug (they come in a few different metals, just get the cheapest one). A quick Google search showed a cost of \$.38, but prices may vary. Remove the metal fitting under the throttle body and replace it with the pipe plug. The plug is tapered and will lock in tight to where the fitting was located.
2. If you had the AOS installed here at Crawford, you can bring the car in and we'll fix it FREE OF CHARGE.
3. If you don't want to hassle with trying to find the part at the hardware store, we will send you one FREE OF CHARGE.

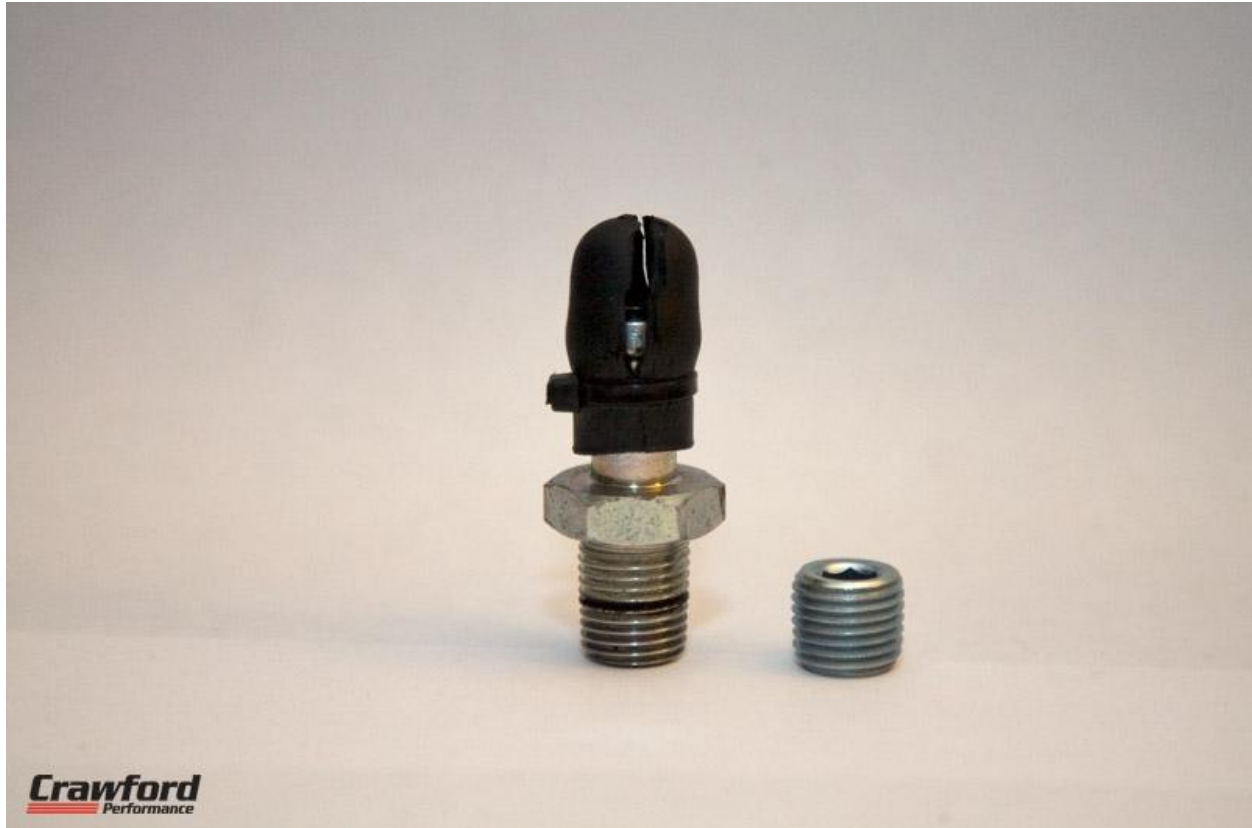
Here is a photo of what the ruptured rubber cap looks like next to the new part that will replace it:
